**Solar Orbiter
Energetic Particles
Detector (EPD)**
EPT-HET ☒ STEP ☐

NCR Title **SO-EPD-KIE-NC-0016 post Vib FT anomalies**

Model . **PQM**

Date: **2015-05-20** Location: **Portsmouth ADS Facilities**

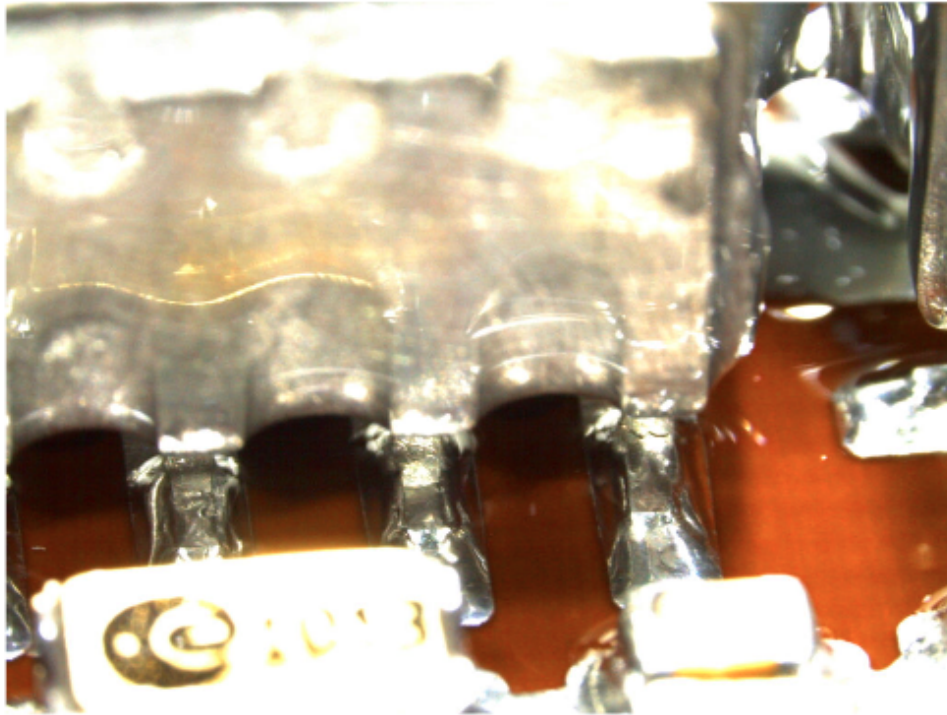
Abb 3 Crack at Capacitor C309

LVPS – staking was not adequate for the capacitors; the PWM generator was glued to the neighbouring capacitor due to close proximity, but had not been intended to be staked at all.

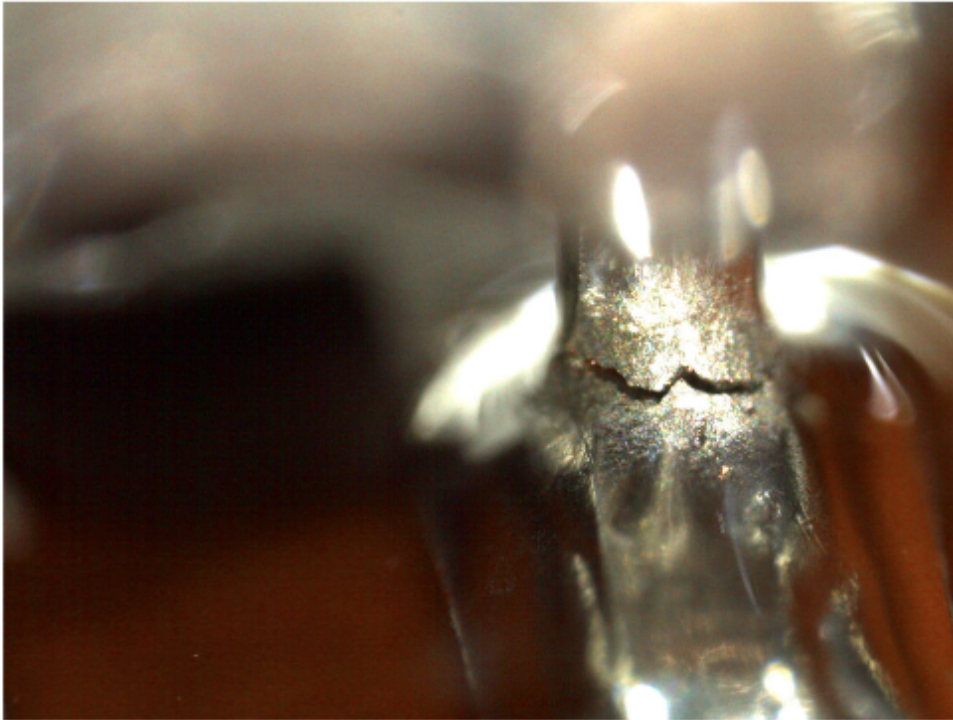
Abb 4 Crack at Capacitor C309 detail

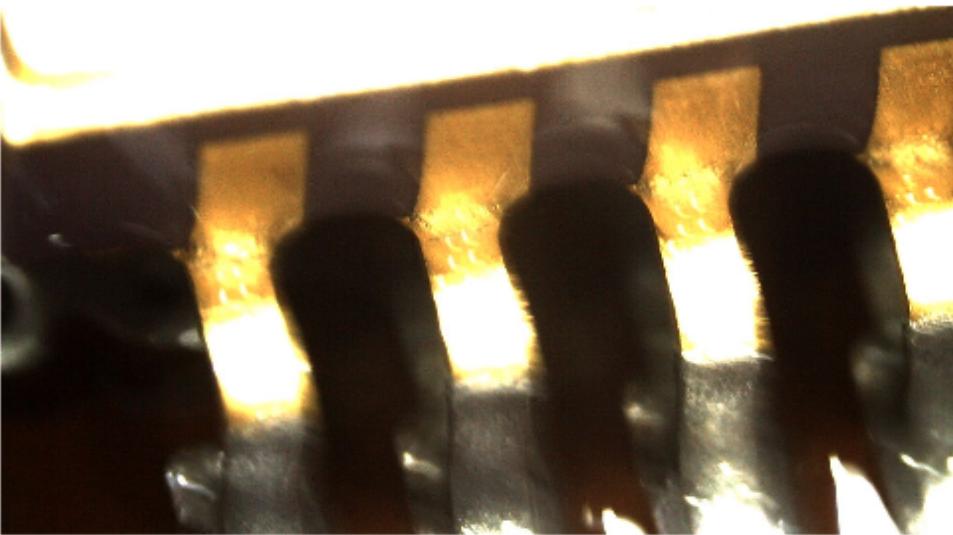
The LVPS has multiple cracks in pins of different parts. Two cracked pins of the PWM generator seems to be the reasons for the falling analog voltage during vibration.

One of the two cracked pins is the feedback input for PWM generator.

Abb 5 Crack on Pin 1 & at IC301

I will fix this error tomorrow. But the parts on board are very stressed now and won't survive a second vibration test.

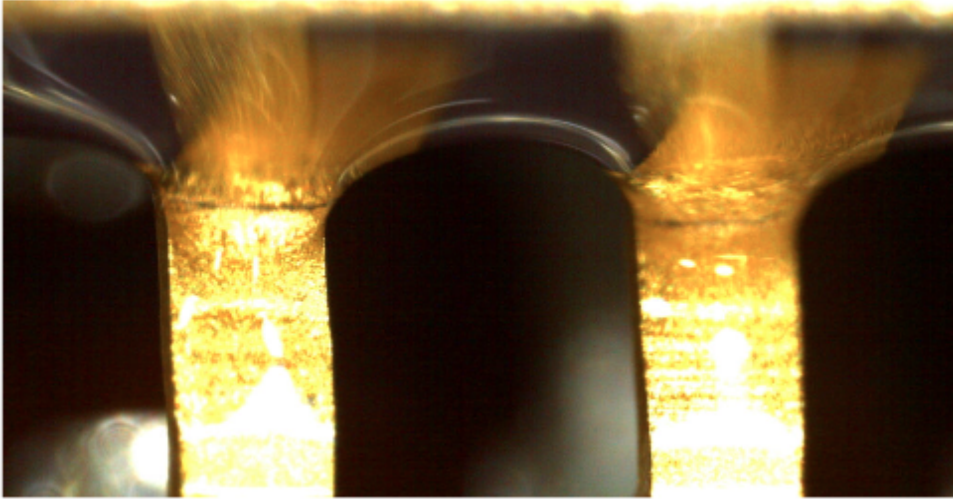
Abb 6 Crack on Pin 1 &2 at IC301 detail 01

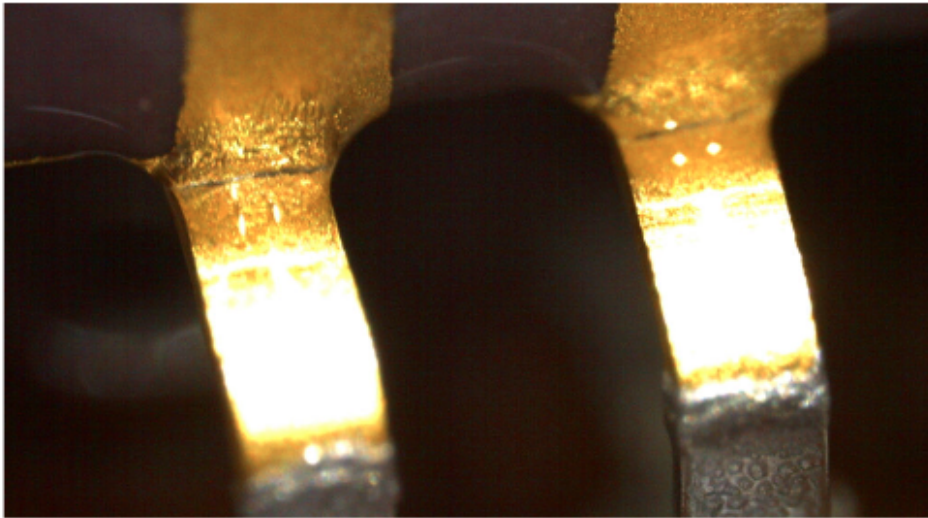
Abb 7 Crack on Pin 1 &2 at IC301 detail 02

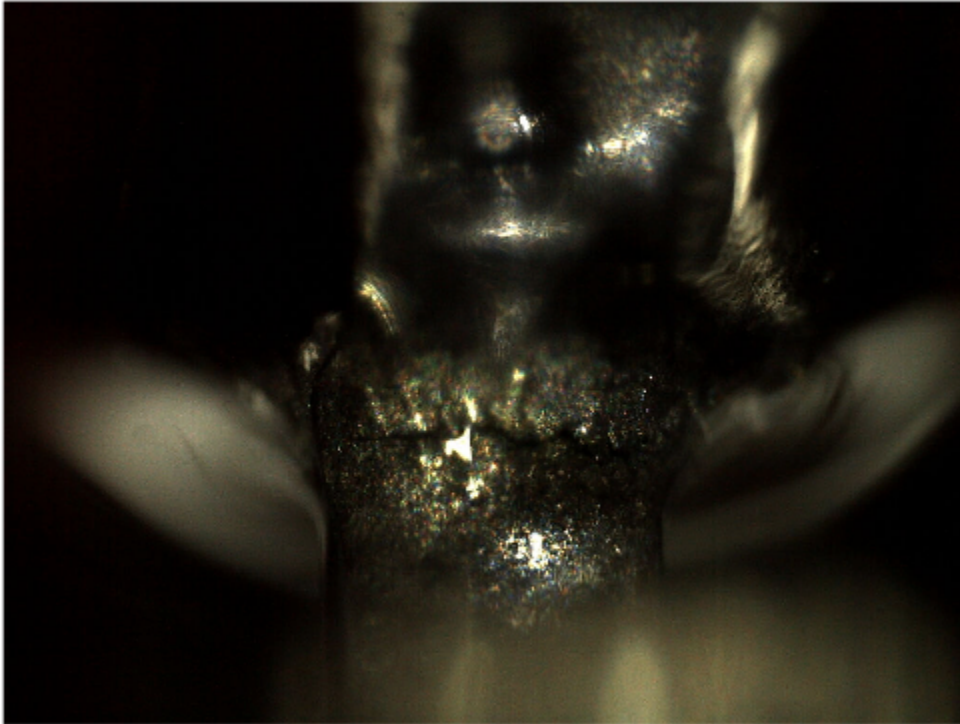
Abb 8 Crack at Capacitor C302

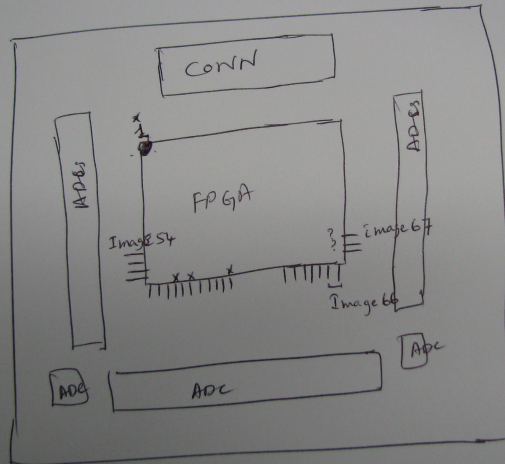
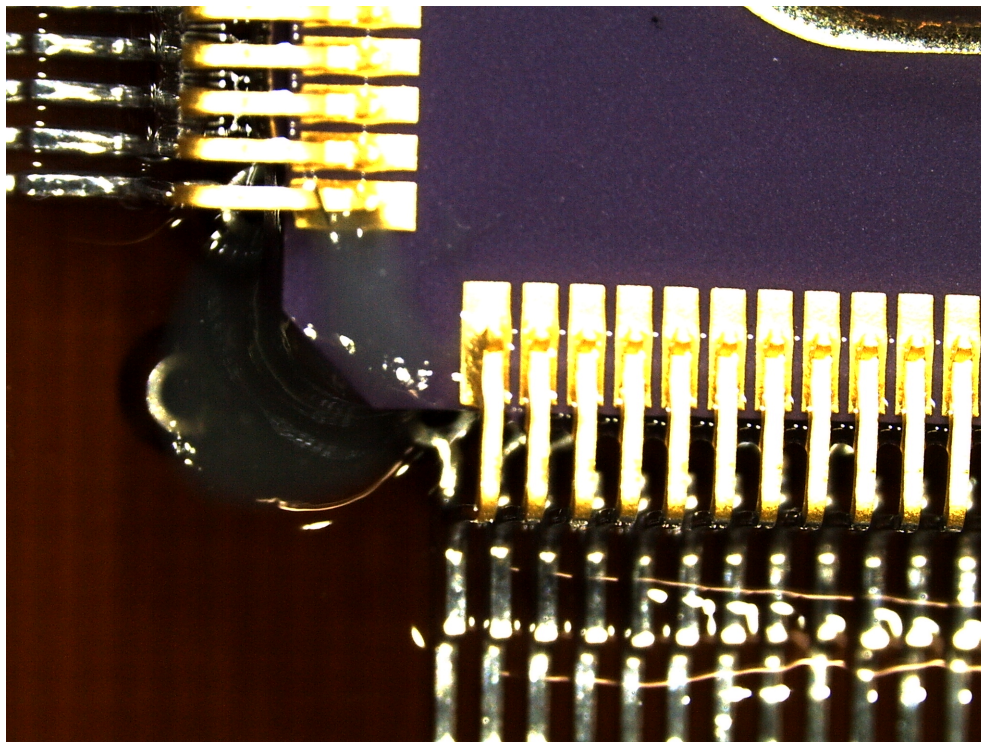
Image 54 to Image 67

(2) On 2015-05-28 Shri Kulkarni posted his investigation of the Analog board. Cracks were observed in FPGA legs, as indicated in the sketched assembly diagram, and documented by photos.

Digital and Analog board FPGAs – the issue is, the FPGA is not adequately supported by the mechanical frame; this is worst for the Analog board where the FPGA is in the center of the board.

Bending of the boards under vibration is the cause of the FPGA broken legs; stiffening the boards by using thicker pcb would help, and improving the fixation of the boards to the frame would help.

For testing STEP, notching during vibration would avoid the same problem with FPGAs.
