**Solar Orbiter
Energetic Particles
Detector (EPD)**
EPT-HET ☒ STEP ☐

NCR Title **SO-EPD-KIE-NC-0016 post Vib FT anomalies**

Model . **PQM**

Date: **2015-05-20** Location: **Portsmouth ADS Facilities**

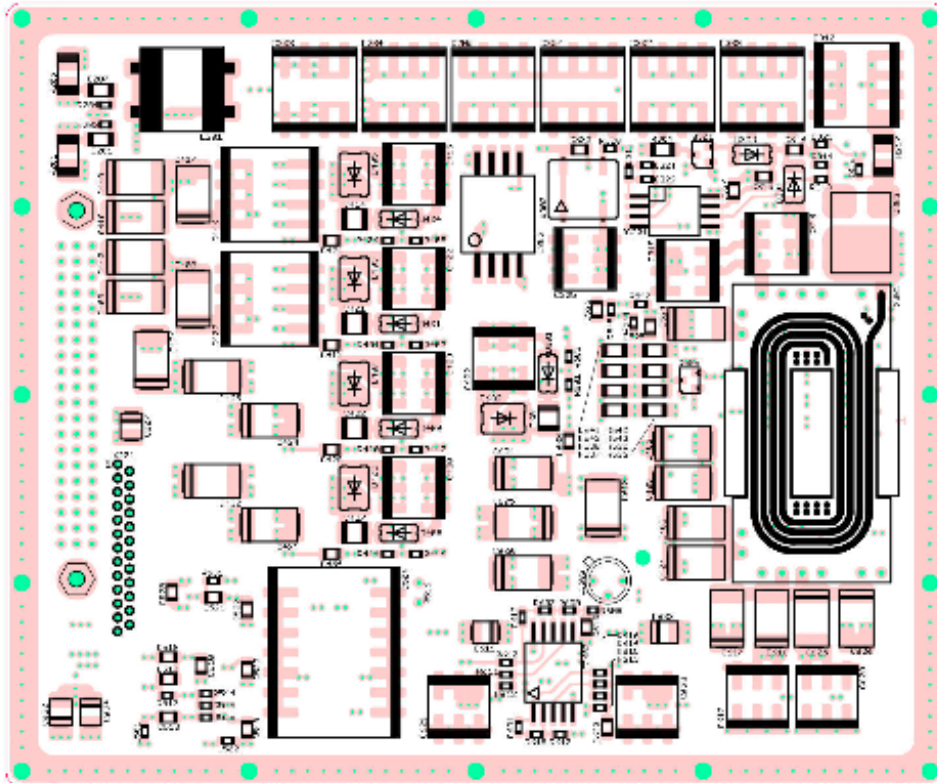
Abb 1 Assembly top

The LVPS has multiple cracks in pins of different parts. Two cracked pins of the PWM generator seems to be the reasons for the falling analog voltage during vibration.

One of the two cracked pins is the feedback input for PWM generator.

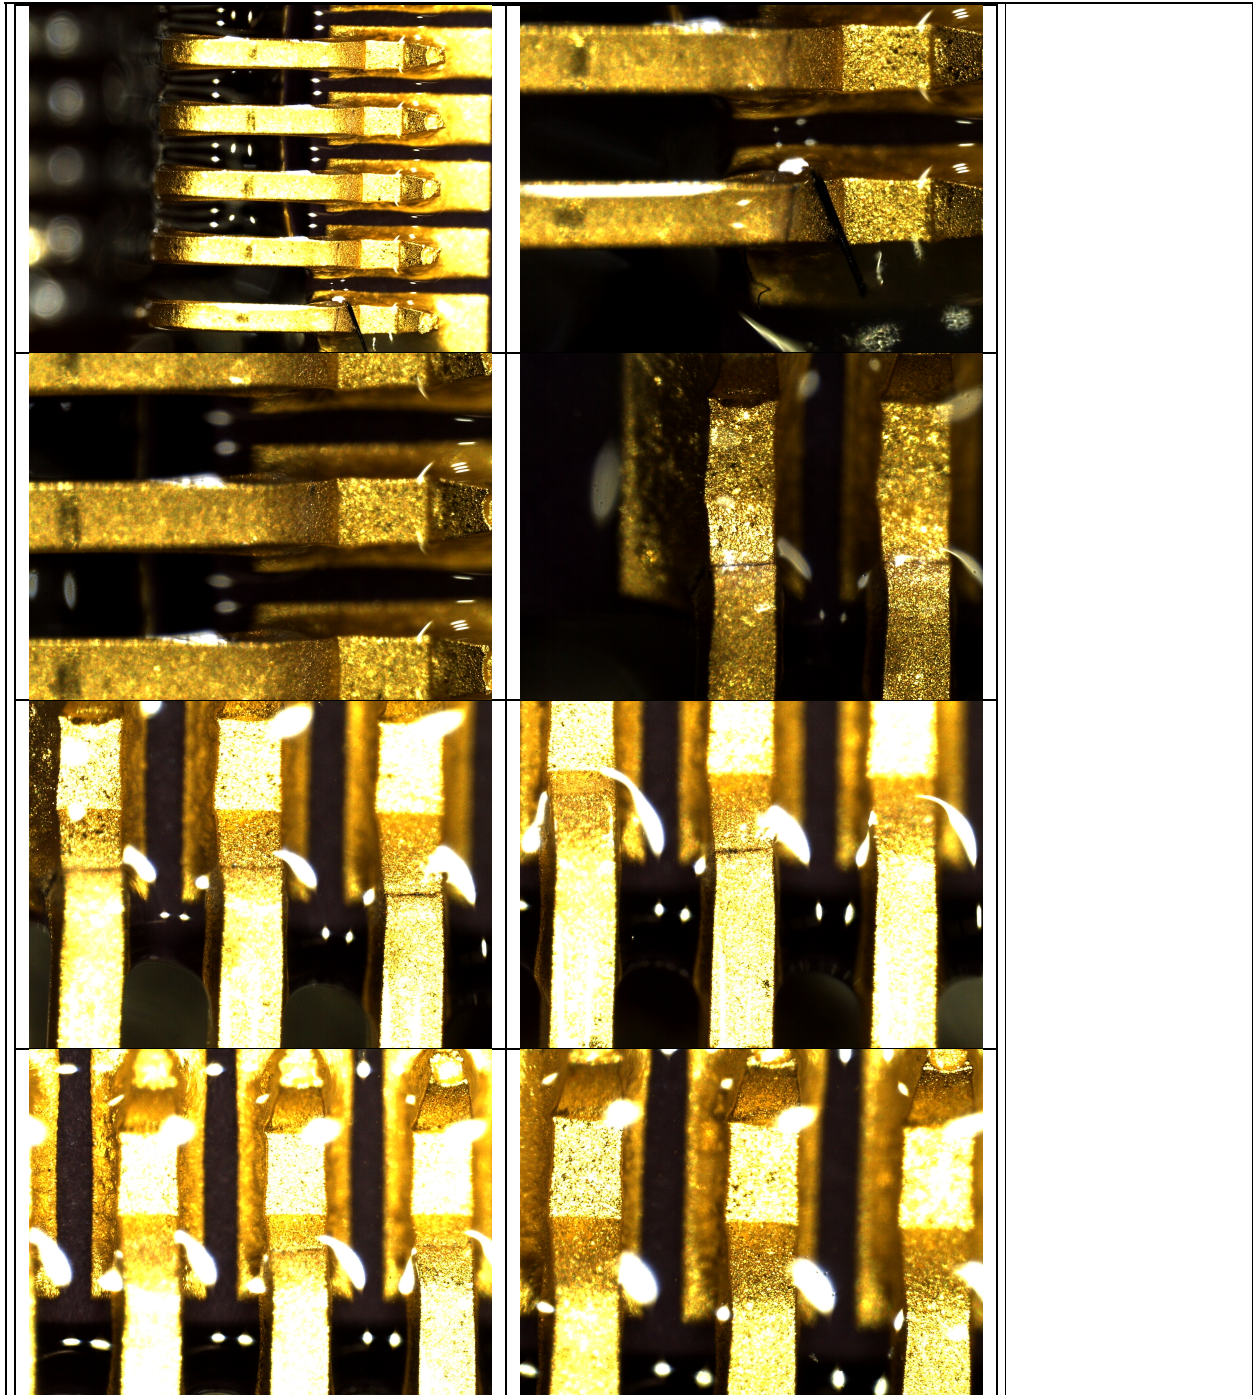
(2) On 2015-05-28 Shri Kulkarni posted his investigation of the Analog board. Cracks were observed in FPGA legs, as indicated in the sketched assembly diagram, and documented by photos.

Bending of the boards under vibration is the cause of the FPGA broken legs; stiffening the boards by using thicker pcb would help, and improving the fixation of the boards to the frame would help.
